SITUATION AND CHARACTERISTICS OF TSUNAMI DAMAGE TO THE TIDE WALLS ALONG THE COAST IN IWATE PREFECTURE RESULTING FROM THE GREAT EAST JAPAN EARTHQUAKE

Tetsuya Oyamada,* Shunsuke Hanehara,* Hideaki Deto,* Shoji Iwasaki*

Iwate University *

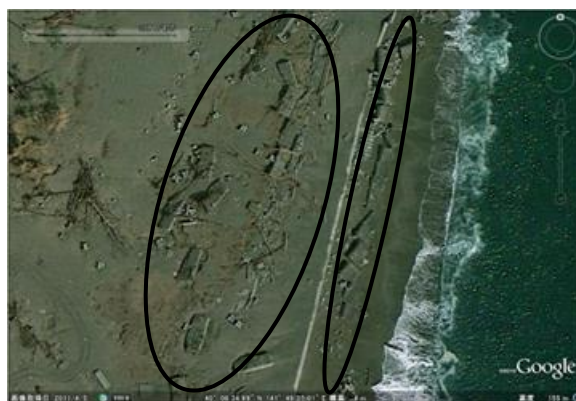
Figure-3 Aerial Photograph of Tofugaura Coast (No. 1)

Figure-3 shows an aerial photograph of the severely damaged Tofugaura Coast area (No. 1). The slightly inclined vertical white line falling a little to the right of the photograph's center indicates that a concrete foundation and concrete superstructures are scattered on both the sea and land sides. A section of the damaged tide wall is shown in Figure-4. There is sea sand inside the wall's structure. Figure-5 shows the collapsed tide wall. In this area, the sea side slope, or the front side slope, of the tide wall has collapsed toward the sea, the concrete blocks which protected the back slope have fallen towards the land side, and the infill sand has flowed out. This damage suggests that spilling waves first knocked down the concrete blocks and scoured the infill sand, the backrush then causing the front slope to fall down.

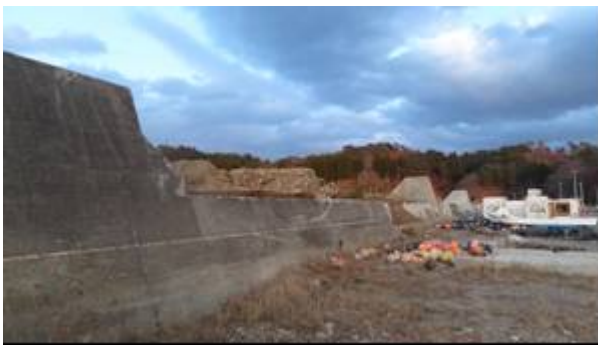
Figure-8 Damaged Tide Wall (North Side) (No. 2)

shore side tide walls. The southern parts of the tide walls had the surface of the back slopes torn off and the infill sand washed out, as shown in [Figure-7](#). In contrast, their northern parts suffered more devastating damage. [Figure-8](#) shows the damage to the northern part photographed from the sea side. The concrete blocks of the front side slope have been knocked down and the infill sand washed out. Only the concrete which supported the front slope

remains.

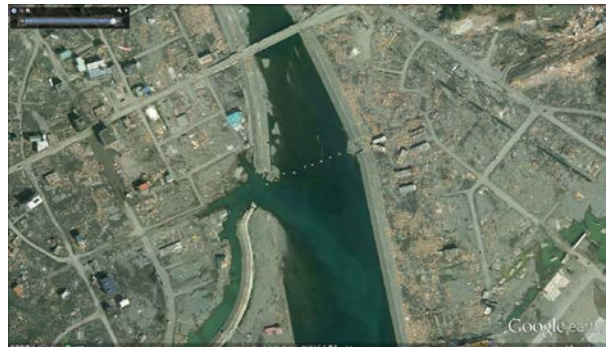
Figure-9 Aerial Photograph of Otsuchi River Bank (No. 6)

[Figure-9](#) shows an aerial photograph of the Otsuchi River ([No. 6](#)) bank after damage by the tsunami. It can be seen that the river bank has been broken and the rear side of the bank flooded with overflowed water. The back slope of the damaged river bank is shown in [Figure-10](#). Similar to the other cases described above, the concrete blocks of the river banks have slipped off, as shown in [Figure-11](#), and

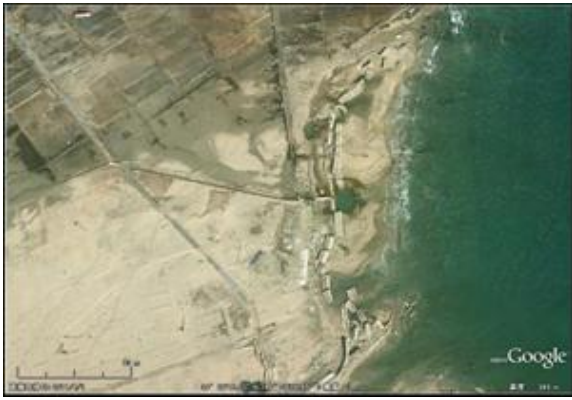
Figure-12 Aerial Photograph of Coast at Yoshihama Agricultural Field (No. 8)

Figure-12 shows an aerial photograph of the coast at Yoshihama Agricultural Field (No. 8) after the tsunami. The white line in the photograph indicates the location of the tide wall before the disaster, its total length being around 0.6 km. The wall collapsed toward the sea side along its entire length. The seaward collapse of the main body of the wall can be

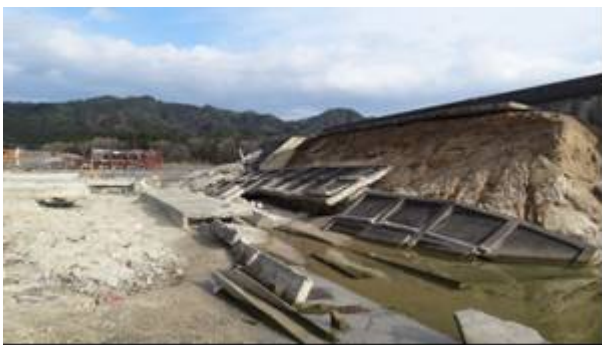
Figure-14 Damage to Tide Wall (No. 4)

The tide wall on the Koyadori Coast (No. 4) also had the back slope torn off and the infill sand washed out, as shown in Figure-14. The damage to the front slope of the wall is shown in Figure-15. Judging from these observations, the backrush is believed to be the reason for the seaward collapse of the tide wall.

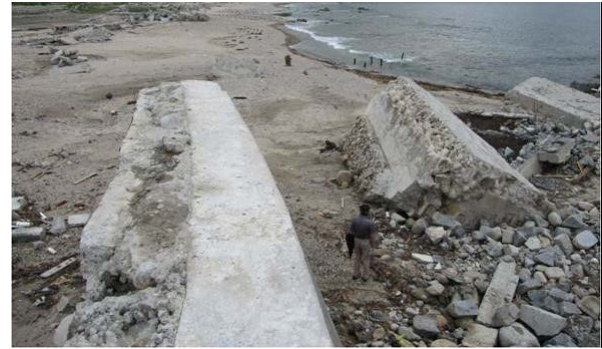
Figure-13 Damage to Tide Wall (No. 8)

seen in Figure-13.

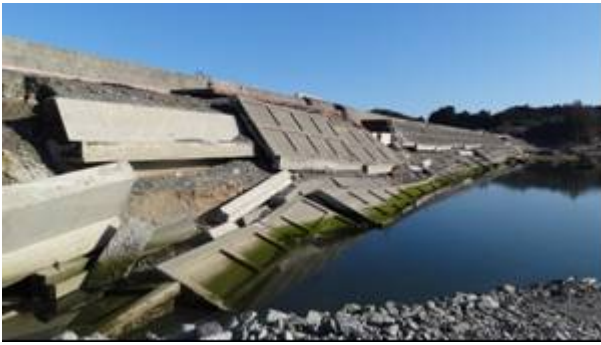
Figure-16 Damage to Tide Wall (No. 10)

In the case of the tide wall on the Mutsugahama Coast (No. 10), the back slope slid down and the infill sand was washed out, as shown in Figure-16. The damage to the front slope of the same tide wall is shown in Figure-17. The concrete blocks were bent at around the center in a vertical direction but no displacement of the wall was observed. This situation suggests that a preceding scouring of the infill sand lessened the support of the concrete blocks.

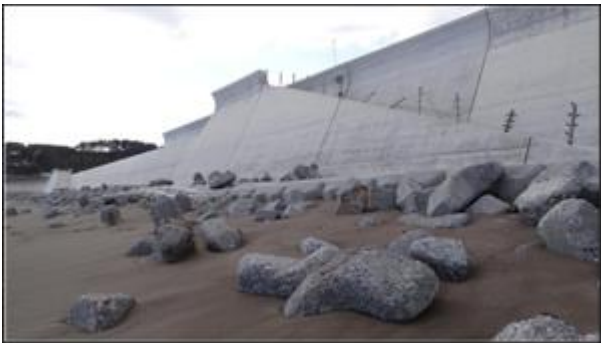
Figure-18 Tide Wall which Did Not Collapse (No. 1)

been constructed. The back slope of the wall was lost and part of the infill sand washed out, but the tide wall itself was saved from collapse, as shown in **Figure-18**. This wall is known to have been constructed at a different time from the other structures. Since we believe that this tide wall can provide valuable information on how to protect tide walls from future tsunami disasters, we are currently studying its details.

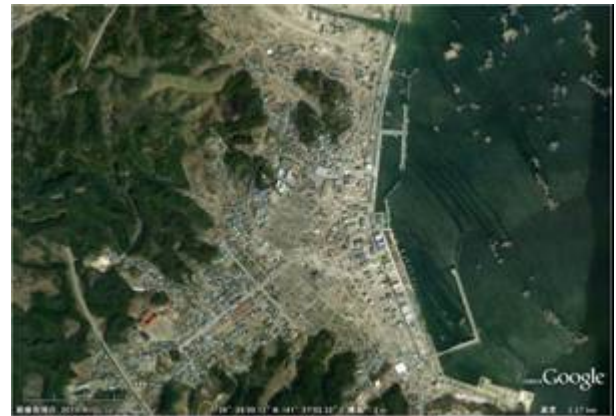
Figure-19 Aerial Photograph of Coast at Yamada Fishery Port (No. 3)

Figure-19 shows an aerial photograph of the coast at Yamada Fishery Port (**No. 3**) after the disaster. In this area, a self-standing tide wall had been

constructed, with a total length of 1.3 km. A large part of the tide wall remains nearly unaffected by the tsunami, except for a severely damaged section of length 0.2 km. In the damaged section, some segments fell down from their bases and others had their parapets torn off, with detritus scattered on the land side, as shown in **Figure-20**. This indicates that the section collapsed because of spilling waves. It can also be seen in the photograph that there are pools of water on the rear side of the original position of the damaged section, which suggests that overflowing and scouring caused the damage. This idea is supported by the fact that no water was discovered on the rear side of the unaffected section. Because urgent restoration work was in progress when we visited the site and the damaged section was protected by sandbags, we could not confirm the damage that had occurred.

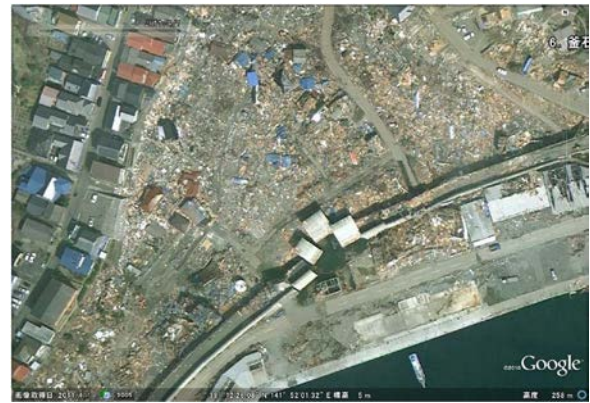
Figure-21 Aerial Photograph of Coast at Kojirahama Fishery Port (No. 7)

Figure-21 shows an aerial photograph of the coast at Kojirahama Fishery Port (**No. 7**) after the disaster. The total length of the tide wall in this area is 0.6 km. The four rectangular blocks in the center of the photograph indicate the location of the damaged section of the wall and the block positions show that the tide wall collapsed or leaned over toward the land side. The damage is shown in **Figure-22**. The soil at the rear side of the collapsed tide wall has

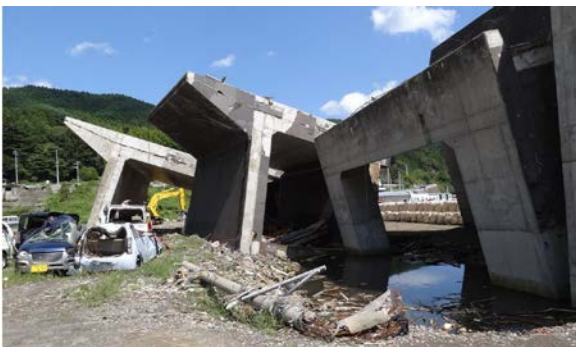
Figure-22 Damage to Tide Wall (No. 7)

largely been scoured and pools of water can be observed. Here again, the scouring is believed to be the reason for the collapse.

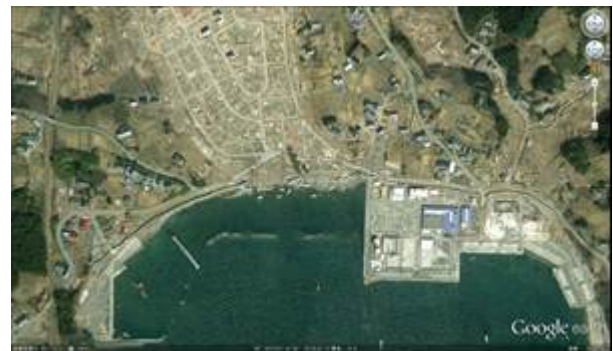
Figure-23 Aerial Photograph of Coast at Kadonohama Fishery Port (No. 9)

An aerial photograph of the coast at Kadonohama Fishery Port Coast (**No. 9**) after the disaster is shown in **Figure-23**. The damage in this area is shown in **Figure-24**. The damaged section of the tide wall collapsed toward the sea side. The wall at the front of the photograph shows seaward collapse and that at the back indicates landward collapse with drifting toward the sea occurring. Some traces of scouring can be seen on the rear side of the tide wall in other sections saved from collapse, as shown in **Figure-25**. The main reason for the scouring is considered to be overflow by the tsunami, the situation also being the same in the collapsed section.
